WATERPROOFING CASE STUDY Charmouth Tunnel, Dorset

NEWTON TUNNEL WATERPROOFING

Road Tunnel Upgraded To 2012 Olympic Sporting Venue

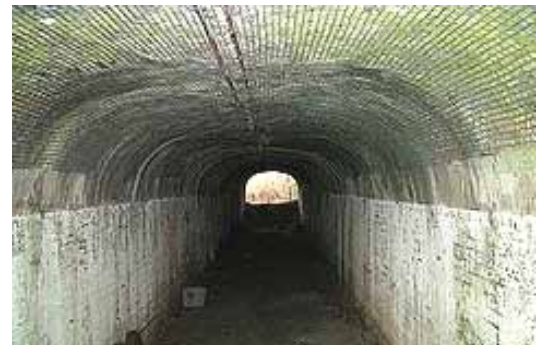
The tunnel suffered from severe damp and water penetration into and through the tunnel. The tunnel is covered by 8 metres of soil.

Charmouth Tunnel suffered from severe damp

Newton 508 and 508 Mesh were used to drain water that was entering the structure from above and prevent the associated mineral deposit stalactites forming. The products are ideally suited to this type and shape of structure as the water drains naturally behind the membrane following the arch shape down to specially formed floor gullies at the base of the walls which run the length of the structure. Water then discharges naturally to the open elevation at the low end of the tunnel.

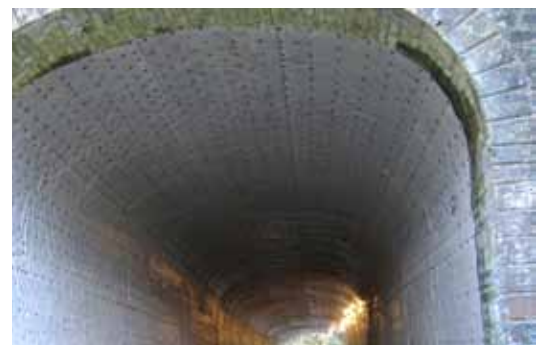
Newton 508 Mesh being applied to the walls

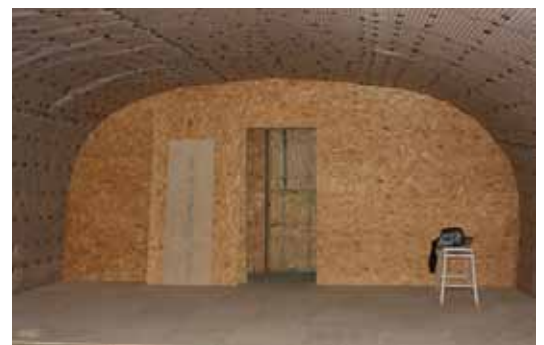
The tunnel is now fully protected from damp and is being transformed into a training facility
